# Manhole Inspection Summary

Manhole # S27CC\_021MH

Insp Date: **11/16/07 1:14 PM**

**Location** Address: **1313 DIVISION ST**

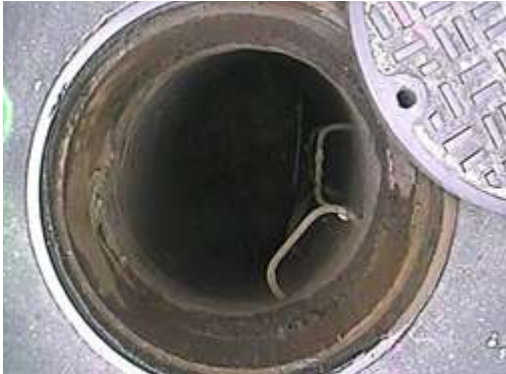
Defect 1

Count: **5** Missing: **0** ☒ **Corroded**

STEPS CORRODED

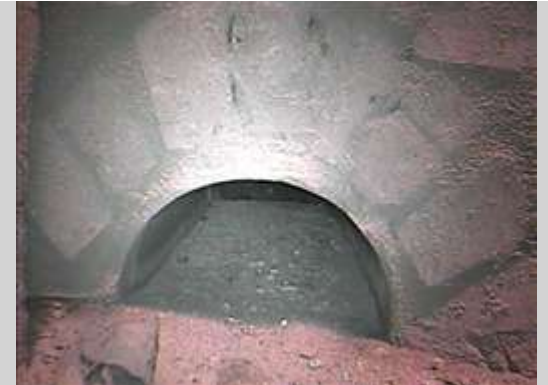
12 O'Clock Outflow

8 in. Circular Gravity Sewer  
Pipe Out @ 12 O'Clock

Deposits: ☐ None ☐ Mud ☐ Sludge ☒ **Debris** ☐ Grease

Silt Depth: **2** (in.) Deposits Extent: **Light**
